**Flood Control Project Maintenance  
Levee Inspections**  
**LMA District Cover Sheet**  
**Spring 2017 Levee Inspection Results**

**Solano County Public Works Mellin Levee**

**Levee Inspection Report By Mile - Spring 2017**

Waterway	Bank	Unit Miles	Inspection Start/End	Inspector
Unit No. 01 Mellin Levee	Right	0.59	03/15/2017 03/15/2017	Richard Willoughby

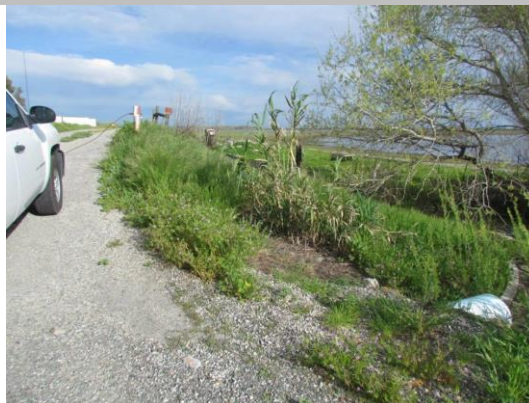
Photo 1 of 1 : SP\_2017\_NA0012\_258\_1\_20170316\_00010.jpg

LM Start	0.00	Rating **	M	Issue No.	1
LM End	0.28	Issue Type +	Ma	Location *	WS
Category	Earthen Levee			GPS Latitude/Longitude	
				Start	End
Item	Vegetation			38.174051 °	38.176920 °
				-121.674220 °	-121.677898 °
DWR ID	DWR_NA0012_01_s _ 2012_1				
Comment Code					
V1 : Control annual grass and weeds on the levee slopes and easements.					
Inspector Comment					
Control Arundo and other veg on waterside slope at the entrance to the levee.

Looking west at typical view of waterward slope.

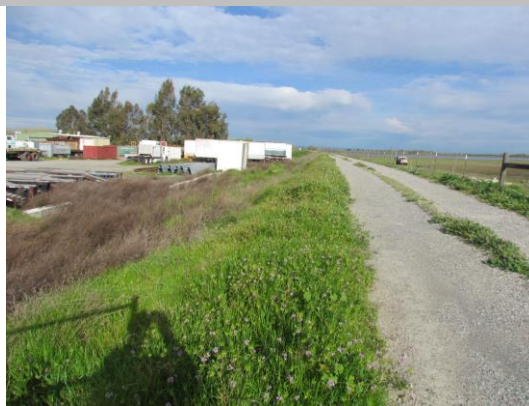
Photo 1 of 1 : SP\_2017\_NA0012\_258\_8\_20170316\_00011.jpg

LM Start	0.00	Rating **	M	Issue No.	8
LM End	0.28	Issue Type +	Ma	Location *	LS
Category	Earthen Levee			GPS Latitude/Longitude	
				Start	End
Item	Vegetation			38.174005 °	38.176920 °
				-121.674303 °	-121.677898 °
DWR ID	DWR_NA0012_01_s _ 2017_8				
Comment Code					
V1 : Control annual grass and weeds on the levee slopes and easements.					
Inspector Comment					
Control annual growth on landward slope.

Looking west at typical view of landward slope.

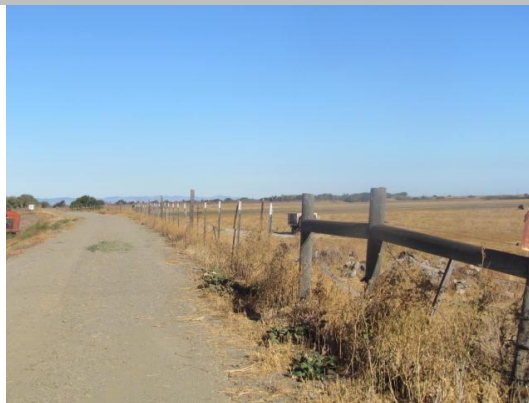
Photo 1 of 1 : SP\_2017\_NA0012\_258\_3\_20170314\_00002.jpg

LM Start	0.01	Rating **	M	Issue No.	3
LM End	0.49	Issue Type +	En	Location *	WS
Category	Earthen Levee			GPS Latitude/Longitude	
				Start	End
Item	Encroachments			38.174167 °	38.178960 °
				-121.674312 °	-121.680600 °
DWR ID	DWR_NA0012_01_s _ 2012_3				
Comment Code					
FE : Fence					
Inspector Comment

Looking west at fence on waterside shoulder.

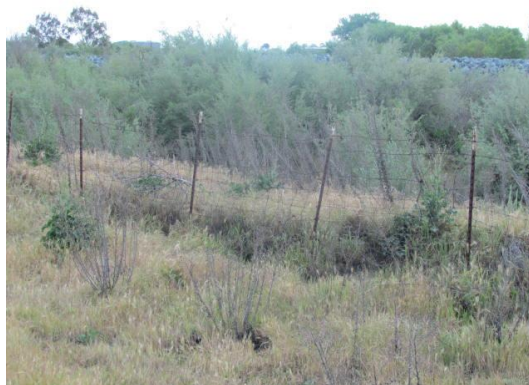
Photo 1 of 1 : SP\_2017\_NA0012\_258\_4\_20170314\_00003.jpg

LM Start	0.10	Rating **	M	Issue No.	4
LM End	0.28	Issue Type +	En	Location *	LS
Category	Earthen Levee			GPS Latitude/Longitude	
				Start	End
Item	Encroachments			38.175115 °	38.176805 °
				-121.675463 °	-121.677893 °
DWR ID	DWR_NA0012_01_s_2012_4				
Comment Code					
FE : Fence					
Inspector Comment

Looking southeast at fence on landward slope.

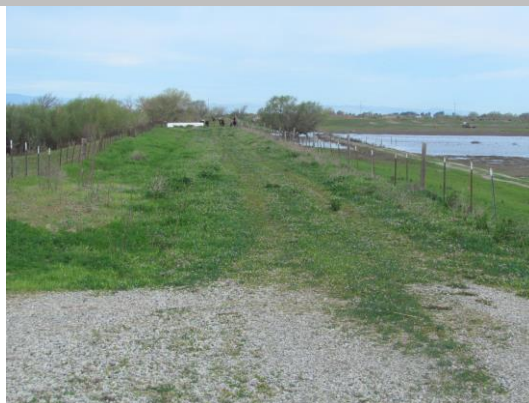
Photo 1 of 1 : SP\_2017\_NA0012\_258\_10\_20170316\_00012.jpg

LM Start	0.15	Rating **	M	Issue No.	10
LM End	0.59	Issue Type +	Ma	Location *	CR
Category	Earthen Levee			GPS Latitude/Longitude	
				Start	End
Item	Vegetation			38.175627 °	38.180044 °
				-121.676185 °	-121.681978 °
DWR ID	DWR_NA0012_01_s_2015_10				
Comment Code					
V1 : Control annual grass and weeds on the levee slopes and easements.					
Inspector Comment					
Control growth on crown roadway.

Looking west at growth on levee crown.

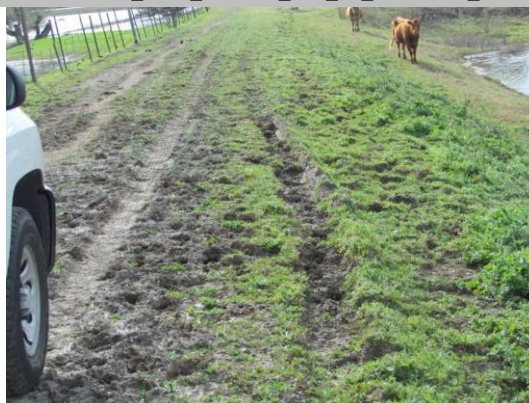
Photo 1 of 1 : SP\_2017\_NA0012\_258\_11\_20170316\_00013.jpg

LM Start	0.36	Rating **	M	Issue No.	11
LM End	0.51	Issue Type +	Ma	Location *	CR
Category	Earthen Levee			GPS Latitude/Longitude	
				Start	End
Item	Crown Surface / Depressions / Rutting			38.177672 °	38.179228 °
				-121.678847 °	-121.680865 °
DWR ID	DWR_NA0012_01_s_2017_11				
Comment Code					
C2 : Repair depressions or ruts in the crown or slope.					
Inspector Comment					
Repair ruts on levee crown.

Looking east at ruts on levee crown shoulder.

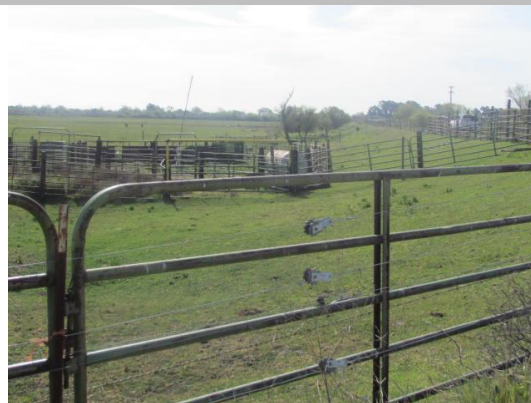
Photo 1 of 2 : SP\_2017\_NA0012\_258\_5\_20170314\_00004.jpg

LM Start	0.57	Rating **	M	Issue No.	5
LM End	0.59	Issue Type +	En	Location *	WS
Category	Earthen Levee			GPS Latitude/Longitude	
				Start	End
Item	Encroachments			38.179783 °	38.180027 °
				-121.681648 °	-121.681978 °
DWR ID	DWR_NA0012_01_s_2012_5				
Comment Code					
FE : Fence					
Inspector Comment					
Animal corral.

Looking east at animal corral on waterside toe.

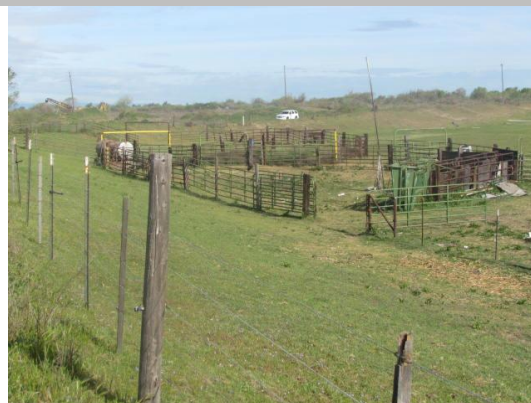
Photo 2 of 2 : SP\_2017\_NA0012\_258\_5\_20170314\_00005.jpg

Looking west at animal corral on waterside toe.

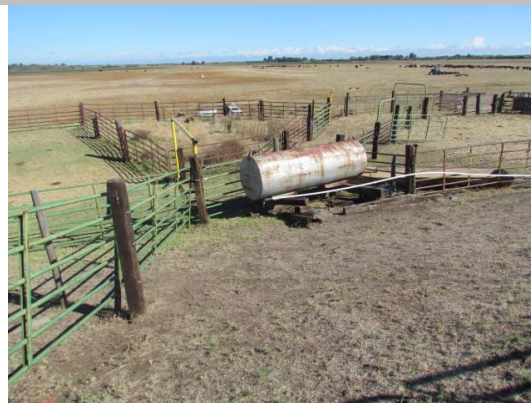
Photo 1 of 1 : SP\_2017\_NA0012\_258\_2\_20170314\_00001.jpg

LM Start	0.58	Rating **	M	Issue No.	2
LM End	0.58	Issue Type +	En	Location *	WS
Category	Earthen Levee			GPS Latitude/Longitude	
				Start	End
Item	Encroachments			38.179951 °	38.179951 °
				-121.681854 °	-121.681854 °
DWR ID	DWR_NA0012_01_f_2015_2				
Comment Code					
TA : Tank					
Inspector Comment					
Water tank and fencing on waterward shoulder and slope.

Looking north at water tank stored at waterward toe.

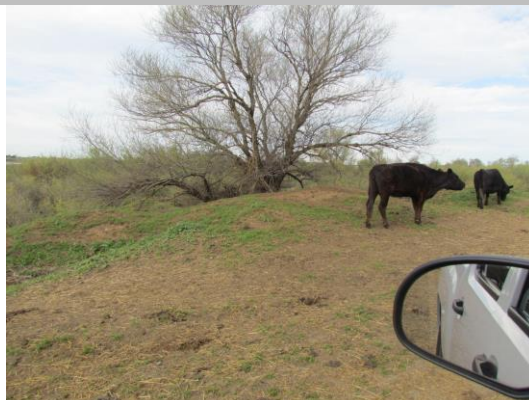
Photo 1 of 3 : SP\_2017\_NA0012\_258\_12\_20170316\_00014.jpg

LM Start	0.59	Rating **	M	Issue No.	12
LM End	0.59	Issue Type +	Ma	Location *	LS
Category	Earthen Levee			GPS Latitude/Longitude	
				Start	End
Item	Trim / Thin Trees			38.180062 °	38.180062 °
				-121.681993 °	-121.681993 °
DWR ID	DWR_NA0012_01_s_2015_12				
Comment Code					
T1 : Trim trees to at least five feet above ground level.					
Inspector Comment					
Untrimmed tree on landward shoulder and slope.

Looking southwest at untrimmed tree on landward slope (Spring 2017)

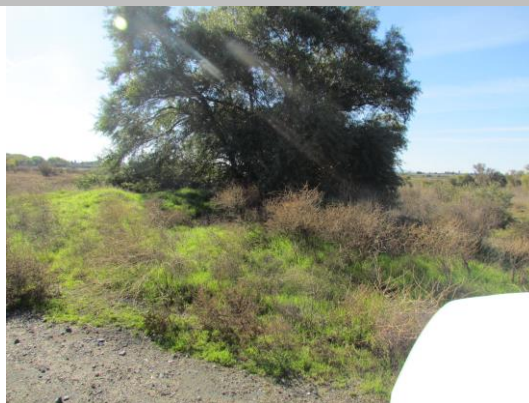
Photo 2 of 3 : SP\_2017\_NA0012\_258\_12\_20170314\_00008.jpg

Looking southwest at untrimmed tree on landward slope. (Fall 2016)

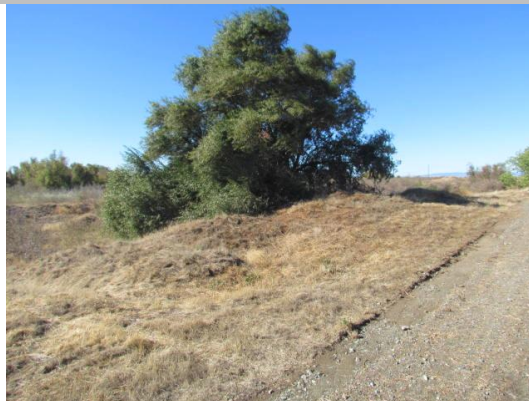
Photo 3 of 3 : SP\_2017\_NA0012\_258\_12\_20170314\_00009.jpg

Looking at untrimmed tree on landward slope fall 2015.
